Accessibility
Self Evaluation and Transition Plan
Apostle Islands National Lakeshore

Apostle Islands National Lakeshore (APIS) has prepared this Self Evaluation and Transition Plan to ensure we are providing comparable opportunities to experience the park to all visitors, regardless of their abilities. As a public entity, APIS is obligated to ensure that our programs, services and facilities are accessible to all visitors based on *Section 504 of the Rehabilitation Act of 1973* which prohibits discrimination against individuals based on disability.

This report was created after conducting site visits to sites and islands within the park and a review of the programs and interpretive media available to park visitors in the summer of 2011. The following documents were used as the basis for recommendations, some of which are specific to the National Park Service:

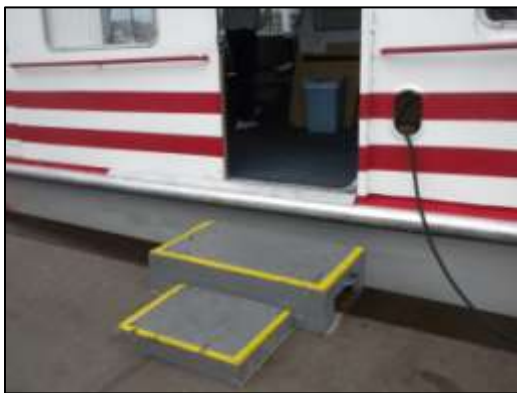
Island Princess. Passenger entry; a ramp is also available.

- Work with the concession operator to ensure that as vessels are replaced or modified, features of accessibility are incorporated. (Timeframe: Immediate)
- Work with the concession operator to provide a vessel that has features of accessibility that docks at islands. (Timeframe: Immediate)
- Work with the concession operator to acquire an assistive listening system that can be used with the narrated audio tour. (Timeframe: Immediate)

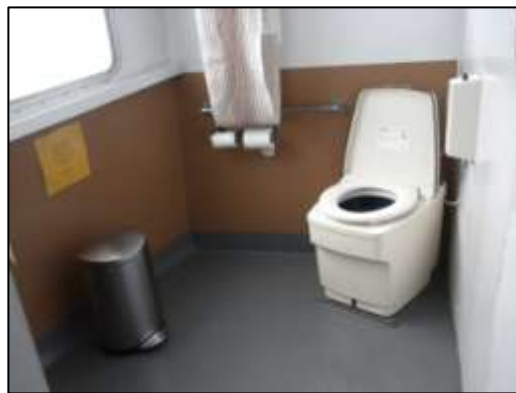
Island Princess. Larger toilet room on the port side.

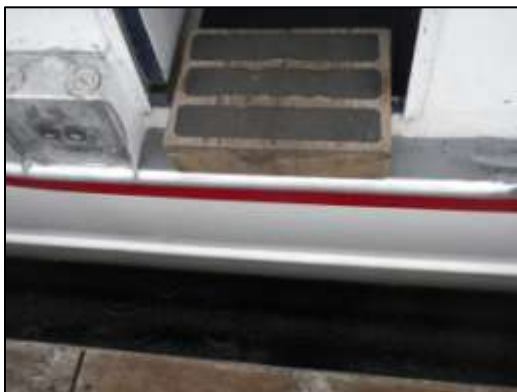
Ashland Bayfield Express. Passenger entry.

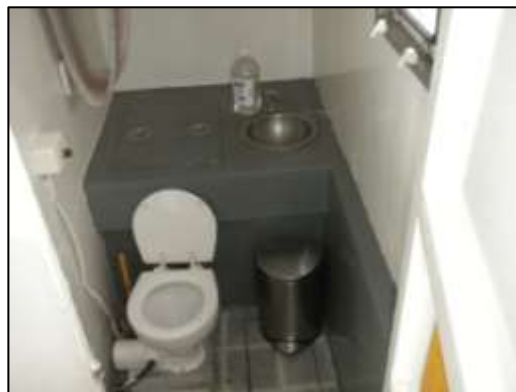
Ashland Bayfield Express. Small toilet room, down 3 steps.

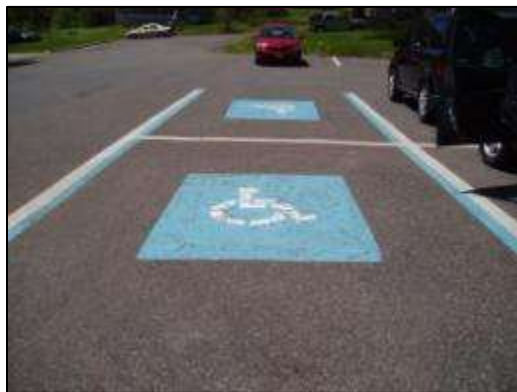
Item	Deficiency	<input type="checkbox"/> Possible Solutions (recommended action identified by:▶)	Barrier Level	Timeframe
Parking	There are 2 designated accessible parking spaces. Currently each is 12' wide. Neither is served by an access aisle. <i>ABA 502</i>	➤ At such time the parking lot is re-striped or re-surfaced, create fully compliant accessible parking spaces, including a van accessible space.	2	Short term
Parking-Signs	The 2 accessible parking spaces are painted with the International Symbol of Accessibility. There is not currently a sign for either space. <i>ABA 502.6</i>	➤ Add a sign. (The current parking layout would allow for a 2 sided sign on a shared post to serve both accessible spaces.)	3	Short term
Accessible Entry- Sign	An accessible entry is provided on the west side of the building. The other entries are not currently accessible. A statement regarding the location of the ramp is currently provided on a wayside style sign near the east entry. <i>ABA F216.6</i>	➤ Post signs at the entries that are not currently accessible- east and south (ceremonial)- directing to the ramp on the west side of the building.	2	Immediate

1. Park Headquarters / Visitor Center. View of accessible parking.

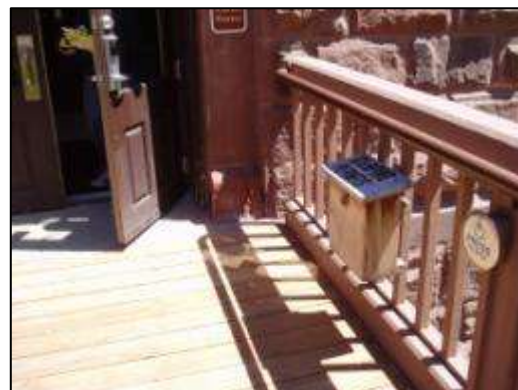
Accessible Entry- Door Width	A single leaf of the double entry doors at the west entry currently provides a 29" clear opening. The power door opener opens both doors. <i>ABA 404.2.3</i>	<input type="checkbox"/> At such time the doors are replaced, replace with a wide/narrow style where a single leaf provides a 32" minimum clear opening. ➤ No action at this time, by activating the power door opener a 32" minimum clear opening is provided.	3	Long term
Sales Counter / Information Desk	The sales counter / information desk is currently at 43". A clipboard is currently available for visitors to complete paperwork. <i>ABA 904.4.1</i>	➤ Lower a 36" wide portion of the counter to a maximum height of 36". <input type="checkbox"/> No action at this time, a clipboard is available.	2	Short term
Theater	A single leaf of the double entry doors at the theater currently provides a 30" clear opening. <i>ABA 404.2.3</i>	<input type="checkbox"/> At such time the doors are replaced, replace with a wide/narrow style where a single leaf provides a 32" minimum clear opening. <input type="checkbox"/> Prop both doors in the 'open' position. (This may impact the viewing of movies because of light and sound from the visitor center.) ➤ No action at this time, a 30" clear opening is considered "usable by" the majority of individuals with disabilities.	3	Short term

4. Park Headquarters / Visitor Center. View of accessible entry. The power door opener activates both of the double doors to provide a 32" clear opening.

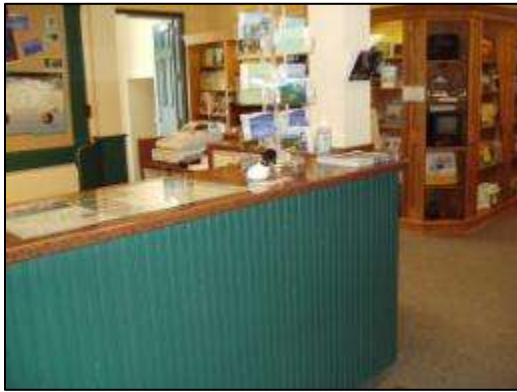
5. Park Headquarters / Visitor Center. View of counter, currently at 43".

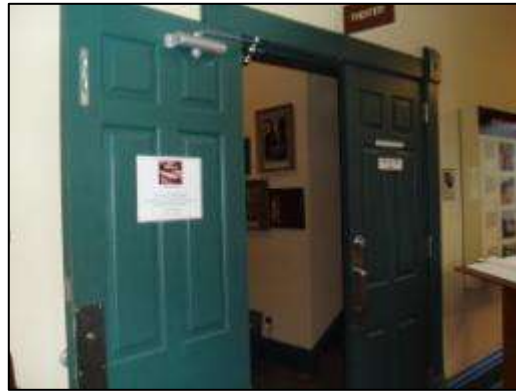
6. Park Headquarters / Visitor Center. View of theater entry. A single leaf of the double doors currently provides a 30" clear opening.

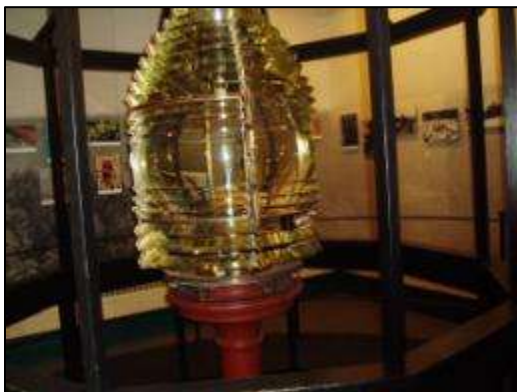
7. Park Headquarters / Visitor Center. View of lens exhibit.

- ☐ Increase the lighting levels at the lens exhibit. (Timeframe: Short Term)
- ☐ Add tactile models and maps. (Timeframe: Long Term)
- ☐ At such time the kiosks are replaced, ensure they comply with Harpers Ferry requirements. (Timeframe: Long Term)

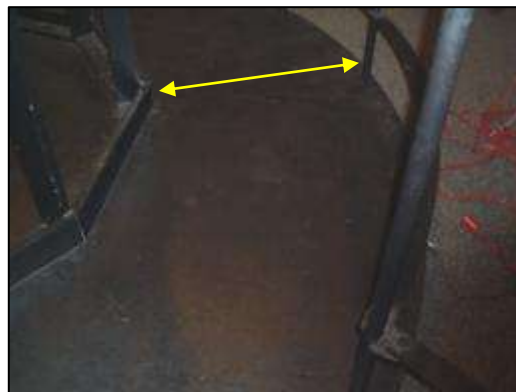
8. Park Headquarters / Visitor Center. View of platform around the lens exhibit. The clear width around the platform is 32 1/2" - 35".

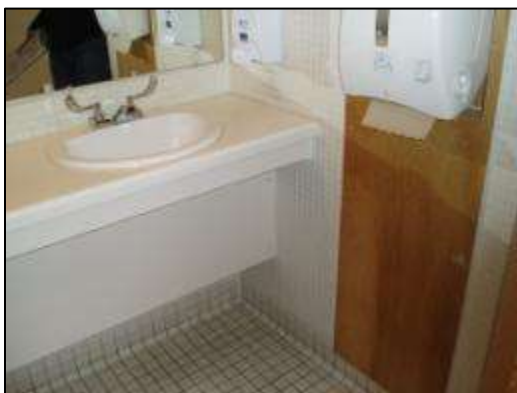
9. Park Headquarters / Visitor Center. View of toilet room. The rim of the sink is currently at 35".

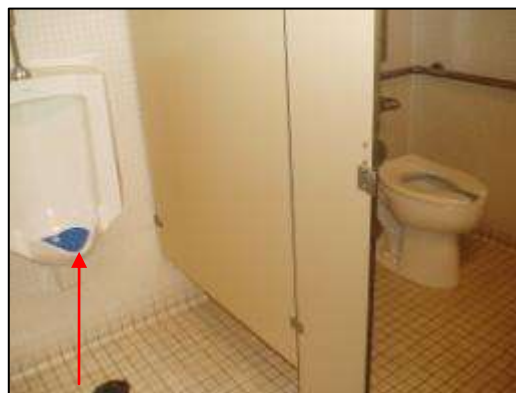
10. Park Headquarters / Visitor Center. The lip of the urinal in the men's room is currently at 24".

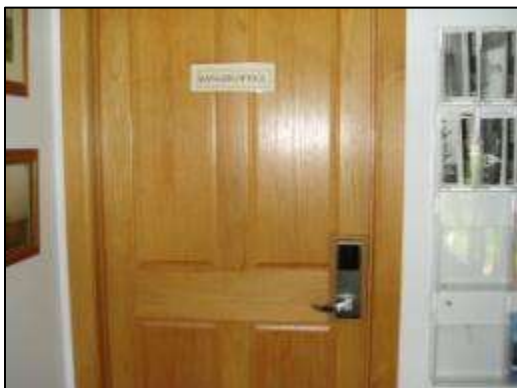
5. APIS Little Sand Bay – Visitor Contact Station. The sign for the Ranger Office is currently paper taped onto the door.

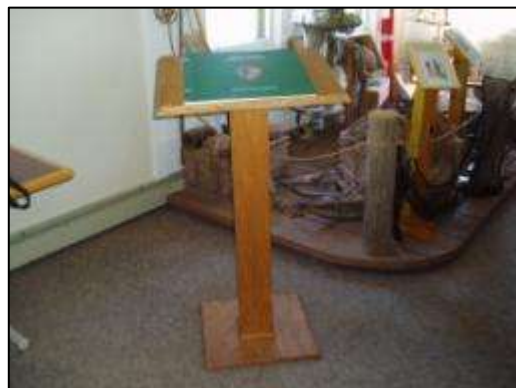
6. APIS Little Sand Bay – Visitor Contact Station. The visitor log is currently on a podium at a height of 42".

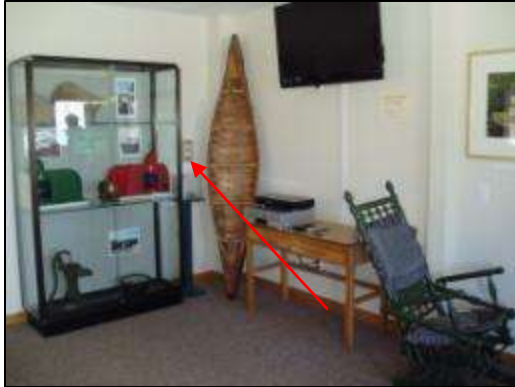
7. APIS Little Sand Bay – Visitor Contact Station. The control for the video is currently located in the corner, at a height of 49".

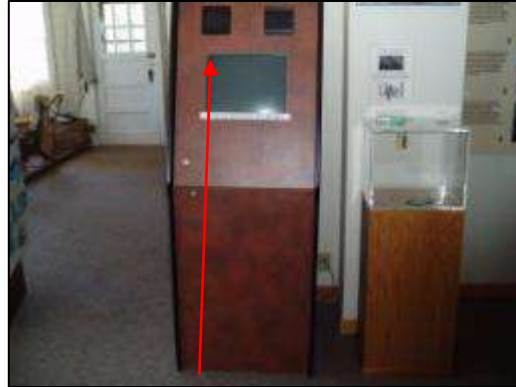
Touch-screen Kiosk	A touch-screen kiosk is available for visitors, the screen is currently 46" to the bottom, 55" to the top. ABA 308	<ul style="list-style-type: none"> ➤ Replace the kiosk with a unit that has the top of the screen (or highest operable part) at 48" maximum. <input type="checkbox"/> Modify the existing kiosk so the screen is no higher than 48". <input type="checkbox"/> Remove the kiosk. 	2	Long term
Video	A video is available for 'on-demand' viewing. A control switch for visitors to start the video is located in a corner at a height of 49". ABA 308, 305	<ul style="list-style-type: none"> <input type="checkbox"/> Relocate the button to a location that provides a clear floor space and 48" maximum height. <input type="checkbox"/> Modify the video start to work with a remote. ➤ No action at this time, a staff person can activate the video from the desk. 	3	Long term
Toilet Room (front)	The toilet is currently centered 20" from the side wall (instead of 16"-18"). A total of 60" clearance is provided. ABA 604.2	<ul style="list-style-type: none"> ➤ Relocate the toilet so it is centered 16"-18" from the side wall. 	3	Long term

8. APIS Little Sand Bay – Visitor Contact Station. The highest operable part of the kiosk is currently at 55".

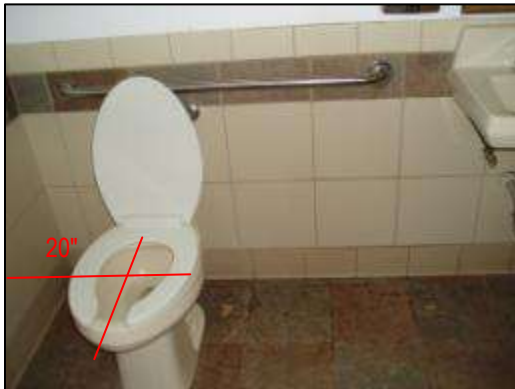
9. APIS Little Sand Bay – Visitor Contact Station. The center line of the toilet in the front toilet room is currently 20".

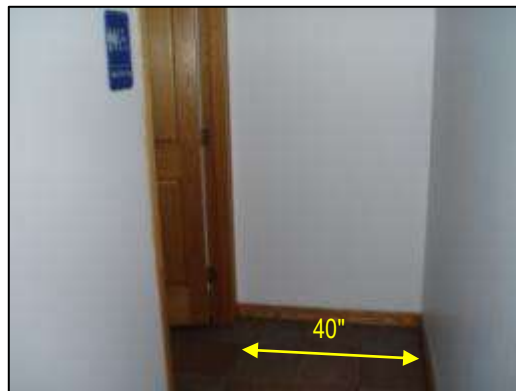
Toilet Room (back)	The waste pipes on the lavatory are not currently insulated. ABA 606.5	<ul style="list-style-type: none"> <input type="checkbox"/> Insulate the pipes at the lavatory. ➤ No action, the front toilet room can be made fully accessible. 	3	Short term
Toilet Room (back)	The locking mechanism for the door currently requires tight grasping and twisting of the wrist to operate. ABA 309.4	<ul style="list-style-type: none"> <input type="checkbox"/> Replace the door lock (integrated into the door lever). <input type="checkbox"/> Add an additional lock. ➤ No action, the front toilet room can be made fully accessible. 	2	Long term

12. APIS Little Sand Bay – Visitor Contact Station. Maneuvering clearance is not currently provided at the door to the back toilet room.

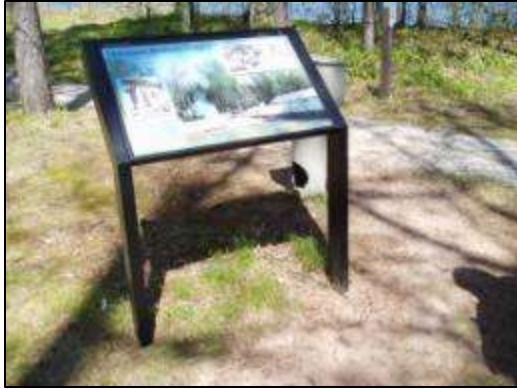
Item	Deficiency	<input type="checkbox"/> Possible Solutions (recommended action indicated by: ►)	Barrier Level	Timeframe
Trailhead- Wayside and brochure box	A wayside and a brochure box are located at the trailhead to the Hokenson Brothers Fishery. Currently both are located approximately 2' from the route. ABA 302	► Expand the hard surface to provide a route and clear floor space at the wayside and brochure box. <input type="checkbox"/> Relocate the wayside and brochure box so they provide a firm, stable surface with a clear ground space.	2	Short term
Route	The route from the parking lot towards the fishery is currently a relatively flat, hard packed stone and is approximately 48" wide. ABA 403	► Maintain the accessible route.	3	Long term
Route- to dock	The primary route to the dock and herring shed is a set of 22 wood steps. An old driveway with a 13.5% slope and approximately 100' distance is also available. ABA 402	► Establish a policy that allows visitors who are unable to use the stairs to drive their personal vehicle down the driveway.	2	Immediate

1. APIS Little Sand Bay – Hokenson Brothers Fishery.
Wayside.

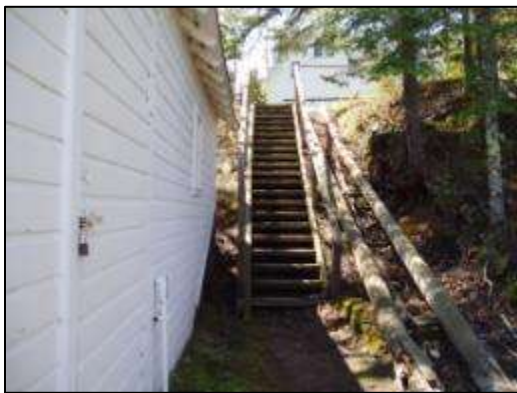
Ice House	The ice house is opened by staff when leading tours. The large sliding door can be opened and the ice house can be viewed from the exterior.	➤ No action, the ice house can be viewed from the exterior.	3	Long term
Dock	The route to the dock and herring shed is currently covered with sand from the beach. <i>ABA 302.1</i>	➤ Sweep the sand off of the route to the dock and the herring shed.	2	Short term
Herring Shed	There is a 6" vertical rise from the dock into the herring shed. It is possible to view into the herring shed from the dock. One of the rooms does not have a door and is open to visitors at all times. The other doors are opened by staff when leading tours. <i>ABA 303</i>	<input type="checkbox"/> Ramp up and create a 'platform' on the dock to eliminate the 6" step into each of the doors. ➤ No action, the shed can be viewed from the dock.	3	Long term
Twine Building	The north end of the twine building has a sliding door that is left in the open position when the visitor contact station is open. A large piece of plexiglass covers the opening to prevent people from entering while still providing a view into the twine building. There is a concrete pad in front of the sliding door. There is not currently a route from the driveway to the twine building (grass). <i>ABA F206.2</i>	<input type="checkbox"/> Create an accessible route from the driveway to the twine building.	2	Short term

3. APIS Little Sand Bay – Hokenson Brothers Fishery.
Route from the twine shed to the dock.

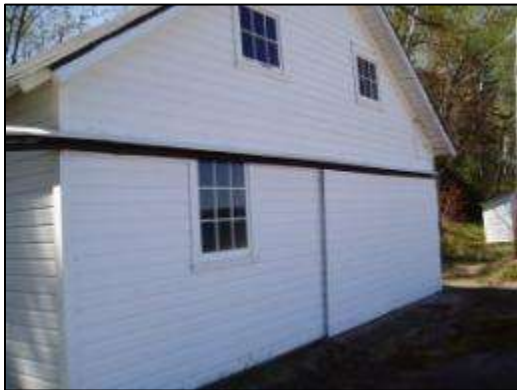
5. APIS Little Sand Bay – Hokenson Brothers Fishery. Ice house.

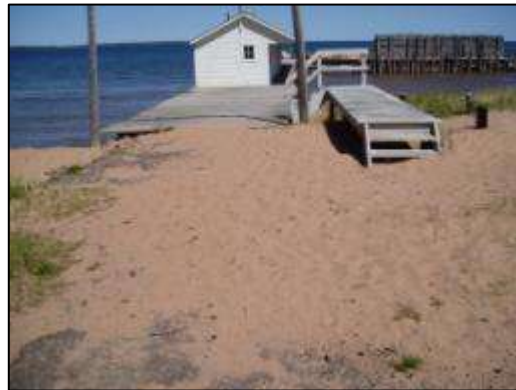
6. APIS Little Sand Bay – Hokenson Brothers Fishery.
Route to herring shed. The stairs and platform on the right are the viewing platform for the Twilight, which is not currently on display.

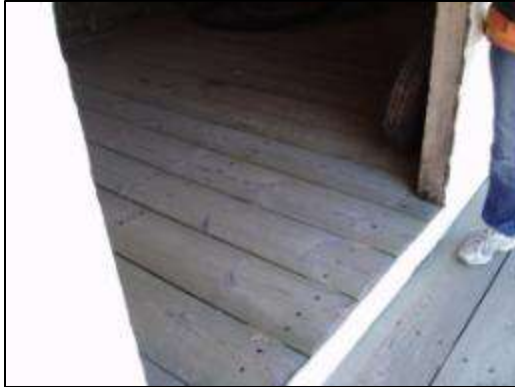
7. APIS Little Sand Bay – Hokenson Brothers Fishery.
Route into herring shed.

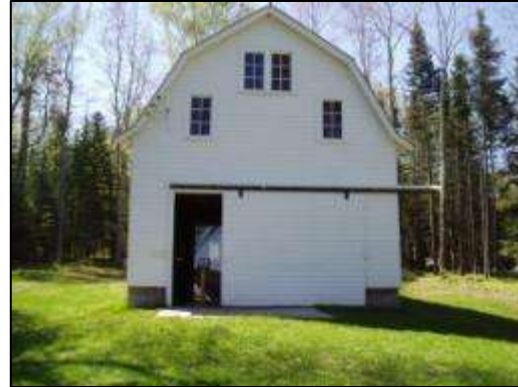
8. APIS Little Sand Bay – Hokenson Brothers Fishery.
Twine shed. The barn door slides open and there is plexiglass that allows for viewing into the twine shed. A concrete pad is provided in front of the opening.

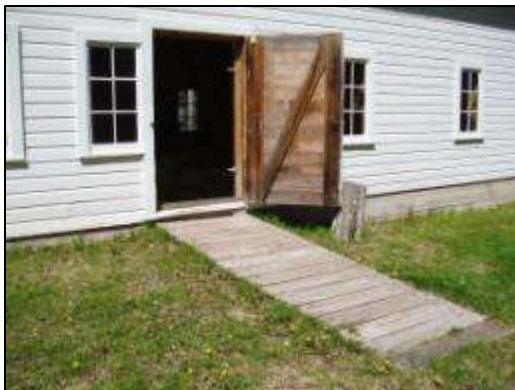
9. APIS Little Sand Bay – Hokenson Brothers Fishery.
Visitor entry to the twine shed. Tours include entering the twine shed through this entry.

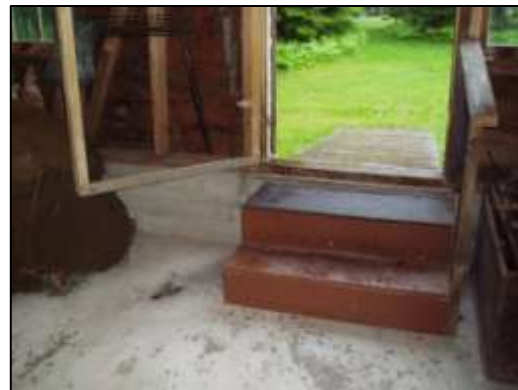
9. APIS Little Sand Bay – Hokenson Brothers Fishery.
Interior view of visitor entry into the twine shed.

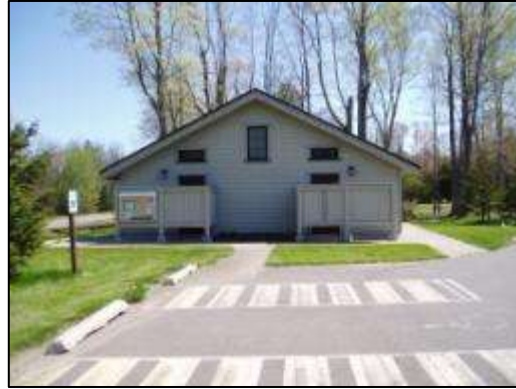
Route	A boardwalk style route has been created from the bathroom to the road. The boardwalk is 5' wide, 24' long and has a slope of 11.9%. <i>ABA 402</i>	➤ Replace the boardwalk with a configuration that has a maximum slope of 1:12 (8.3%).	2	Short term
Route	A boardwalk style route ends 11' from the road. The surface between the boardwalk and the road is rock (approximately 1"-2" diameter). <i>ABA F206.2</i>	➤ Provide a firm, stable surface between the end of the boardwalk and the road.	2	Short term
Men's and Women's Bathroom	There is not currently a raised and Braille sign at the entry to the bathrooms. <i>ABA F216.8</i>	➤ Add a sign with raised and Braille characters.	2	Short term
Men's and Women's Bathroom	The waste pipes on the lavatory are not currently insulated. <i>ABA 606.5</i>	➤ Insulate the pipes at the lavatory.	3	Short term
Men's and Women's Bathroom	The mirror is currently at 41 1/2" to the reflective surface (versus 40"). <i>ABA 603.3</i>	<input type="checkbox"/> Lower the existing mirror to 40" maximum to the reflective surface. ➤ Add a full height mirror.	2	Long term

2. APIS Little Sand Bay Restrooms. View of restroom building and route from parking.

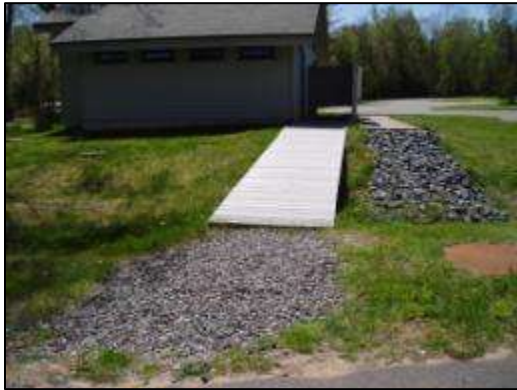
3. APIS Little Sand Bay Restrooms. Route from restroom building to visitor contact station.

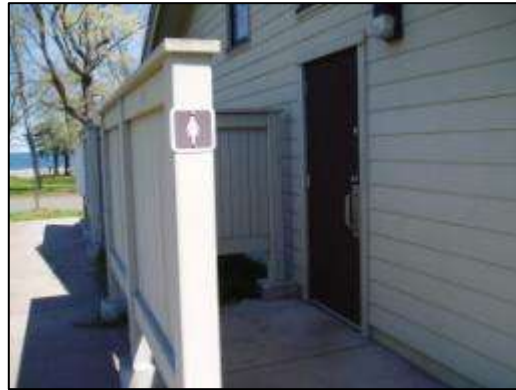
4. APIS Little Sand Bay Restrooms. Entry and signage at restroom.

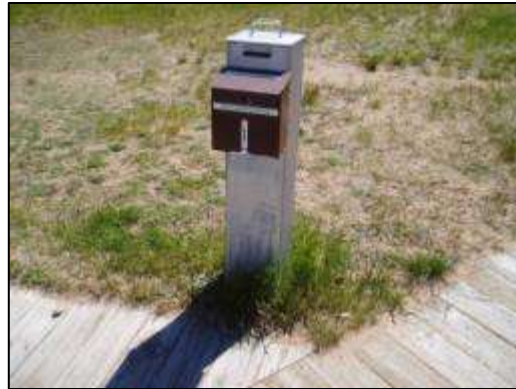
2. APIS Little Sand Bay. Fee station at dock.

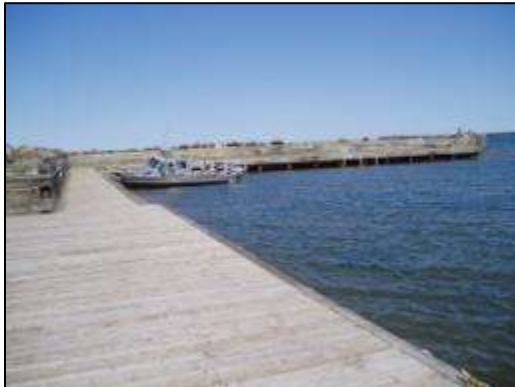
3. APIS Little Sand Bay. Dock.

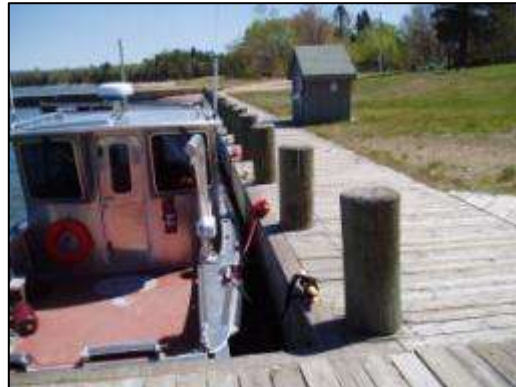
4. APIS Little Sand Bay. Dock. (See photo 9 for view of modified deck.)

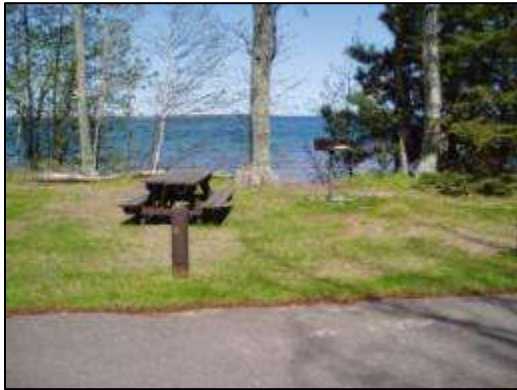
Grills	There are 2 grills positioned in the grass near the visitor contact station. Currently neither of the grills is located on an Outdoor Recreation Access Route (ORAR); 1 is at 35", 1 is at 44". <i>Draft Accessibility Guidelines for Outdoor Developed Areas 1011.5</i>	□ Replace the grill with an accessible style and provide an ORAR. ► Remove the grills.	2	Long term

7. APIS Little Sand Bay. Picnic area and grill near the visitor contact station.

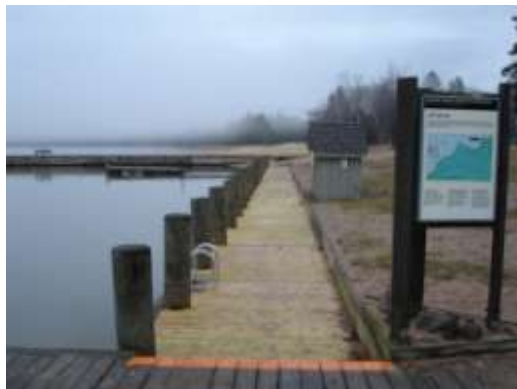
9. APIS Little Sand Bay. View of vertical change between dock segments.

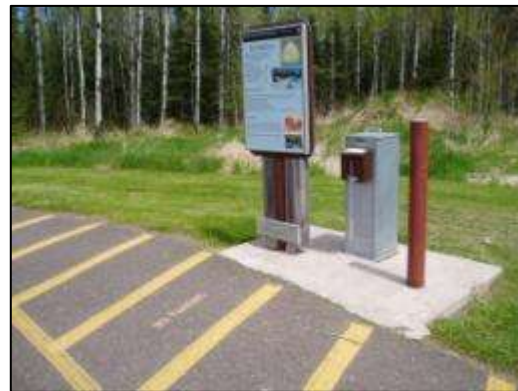
Item	Deficiency	<input type="checkbox"/> Possible Solutions (recommended action indicated by: ►)	Barrier Level	Timeframe
Fee Station	The fee station is positioned along an accessible route. The approach to the fee station is currently obstructed by the information sign. <i>ABA 305</i>	<ul style="list-style-type: none"> ➤ Relocate the information sign to provide a 30"x48" approach to the fee station. <input type="checkbox"/> Relocate the fee station so it is not obstructed by the informational sign. 	2	Short term
Ranger Dugout	A ranger dugout is provided near the stairs to the beach. There is currently a 12" step up to the dugout. <i>ABA F206.2</i>	<ul style="list-style-type: none"> ➤ Construct a ramp up to the dugout. 	2	Short term
Ranger Dugout-Picnic Table	There is 1 picnic table provided in the ranger dugout. The picnic table does not currently provide knee or toe clearance. <i>Draft Accessibility Guidelines for Outdoor Developed Areas 1011.4</i>	<ul style="list-style-type: none"> <input type="checkbox"/> Replace the picnic table with a style that provides knee and toe clearance. ➤ Swap this picnic table with one of tables located near the outhouse that provides knee and toe clearance. <input type="checkbox"/> At such time a ramp to the dugout is provided, ensure the picnic table provides knee and toe clearance. 	2	Short term

2. APIS Meyers Beach. View of fee station. The information sign currently blocks the approach to the fee station.

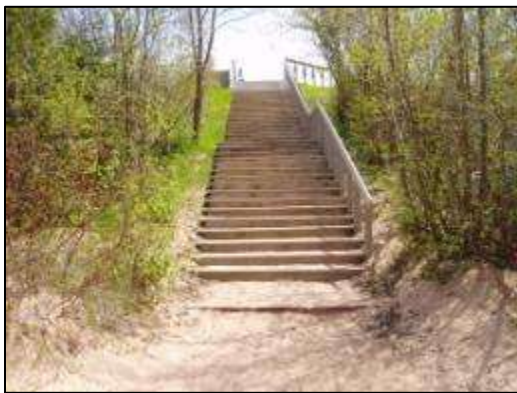
Beach Access Route	The route from the parking lot to the beach is currently 47 steps (8' wide, 16" tread depth, 6" rise). <i>Draft Accessibility Guidelines for Outdoor Developed Areas F248</i>	<ul style="list-style-type: none"> ➤ Create an accessible beach access route by constructing a ramp (including handrails). 	1	Long term
Beach Access-Wayside and Brochure	There is a 3 panel wayside with brochure boxes on the end closest to the stairs. The wayside is currently 2' to 6' off of the accessible route. The ground surface has become compacted in front of the wayside. <i>HFC Programmatic Accessibility Guidelines</i>	<ul style="list-style-type: none"> <input type="checkbox"/> Relocate the wayside so it is positioned along the accessible route. ➤ Expand the accessible route so a firm and stable surface is provided in front of the wayside. 	3	Short term
Beach Access-Wayside and Brochure	The brochure boxes are currently at 38" and 55". (They were empty at the time of site inspection.) <i>ABA 308</i>	<ul style="list-style-type: none"> ➤ Provide some of both brochures in the box at 38". <input type="checkbox"/> Lower the box from 55" to 48" maximum (it may not be possible to fit both boxes on the same post). 	3	Short term

5. APIS Meyers Beach. Route from parking lot to beach.

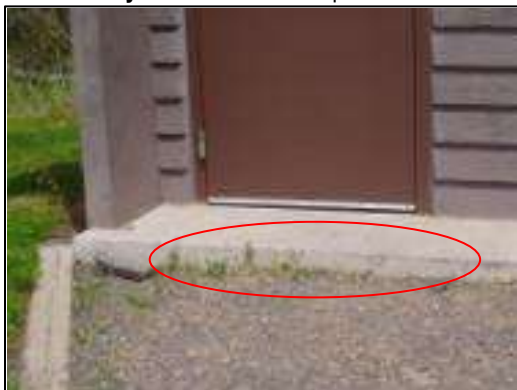
Outhouse-Route	A route has been provided from the parking lot to the outhouses (2 within 1 building). There is currently a 3" vertical change between the ground surface and the concrete pad the outhouse is positioned on. <i>Draft Accessibility Guidelines for Outdoor Developed Areas 1016.5</i>	➤ Eliminate the 3" vertical change.	2	Short term
Outhouse-Sign	The sign at the bathroom currently has Braille. Raised tactile characters are not currently provided. <i>ABA F216.8</i>	➤ Replace the existing sign with a style that provides raised and Braille characters.	3	Long term
Trash / Recycling	A 4 compartment trash and recycling unit is currently provided near the outhouse. A boardwalk is positioned in front of the unit. The timber border at the pedestrian route creates an obstacle to providing an accessible route to the unit. <i>Draft Accessibility Guidelines for Outdoor Developed Areas 1011.2.1</i>	➤ Modify the timber border to create an accessible route to the trash / recycling unit. (Could be coordinated with eliminating the 3" vertical change to the concrete pad of the outhouse.)	2	Long term

13. APIS Meyers Beach. View of vertical change in level at vault toilet.

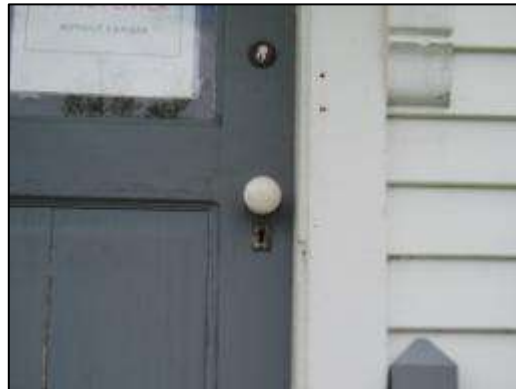
10. APIS Raspberry Island. Knob style door hardware on the visitor entry to the lighthouse.

Lighthouse-Rear Entry	The operable door hardware at the rear entries is currently a knob. ABA 309.4	<input type="checkbox"/> Replace the knob style hardware with a style that does not require tight grasping, pinching or twisting of the wrist to operate (such as a lever). ➤ No action at this time. The doors are opened by staff (or volunteers) when the building is open for tours.	2	Long term
Lighthouse-Interior Doors	The clear opening of the interior doors is currently 31". ABA 404.2.3	<input type="checkbox"/> Remove and replace the doors with a style that provides 32" clear opening. <input type="checkbox"/> Remove the doors. ➤ No action at this time, a 31" clear opening is considered "usable by" the majority of individuals with disabilities.	3	Long term

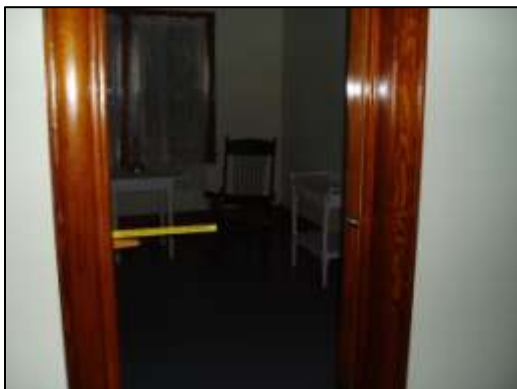
11. APIS Raspberry Island. View of lighthouse interior doors.

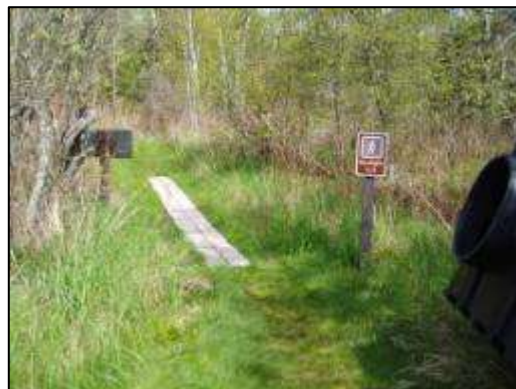
12. APIS Raspberry Island. View of trailhead

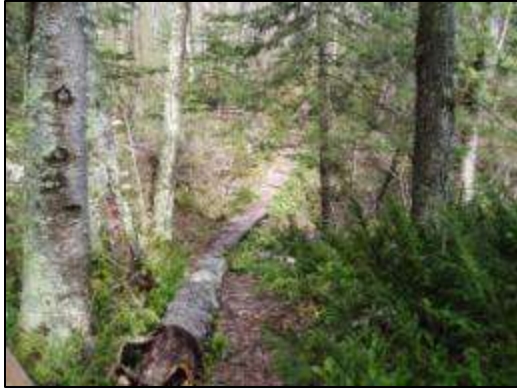
13. APIS Raspberry Island. View of trail surface.

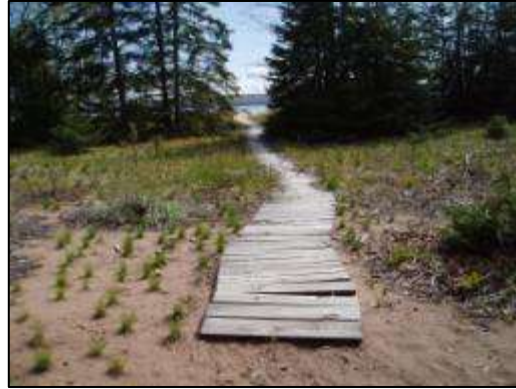
14. APIS Raspberry Island. View of boardwalk at sandspit.

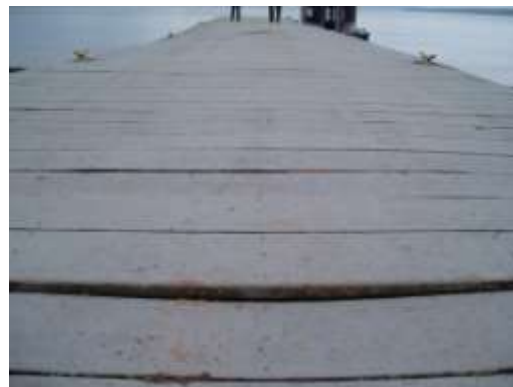
Item	Deficiency	<input type="checkbox"/> Possible Solutions (recommended action indicated by: ►)	Barrier Level	Timeframe
Dock: <i>The public dock is located at the east side of Sand Island. The dock is currently 12' wide and 150' long (approximately 45' of usable length).</i>				
Dock	The surface of the dock is currently 'wavy' with multiple changes in elevation, gaps between boards and varying cross slopes. <i>ABA 1003.2, 401</i>	<input type="checkbox"/> Replace the walking surface of the dock. ► Replace the dock in its entirety.	2	Short term
	There is not currently an accessible route to the island from the dock. The dock currently ends in soft sand. <i>ABA F206.2</i>	► Create an accessible route to the island from the dock.	2	Short term
Light Station National Register of Historic Places				
Route	The route around the Light Station Quarters is currently concrete slab. The slabs around the Light Station Quarters are 28" wide x 40" long. The slabs toward the lake, trail and outbuilding are 18" wide x 40" long. <i>ABA 403.5.1</i>	<input type="checkbox"/> Replace the concrete slabs with a firm, stable, slip resistant surface that is 36" wide minimum. <input type="checkbox"/> Add additional width to concrete slabs by adding new precast units adjacent to existing to achieve an accessible width. ► Create an accessible route at the light station.	2	Long term

2. APIS Sand Island. Dock surface.

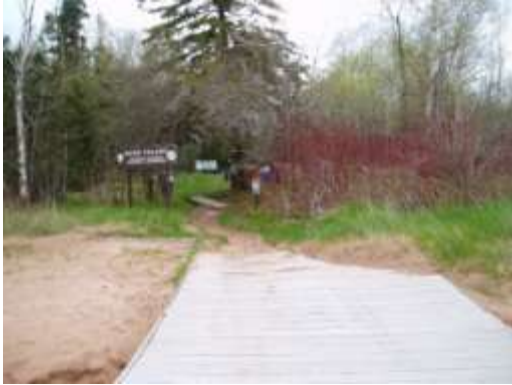
3. APIS Sand Island. Dock ends in soft sand.

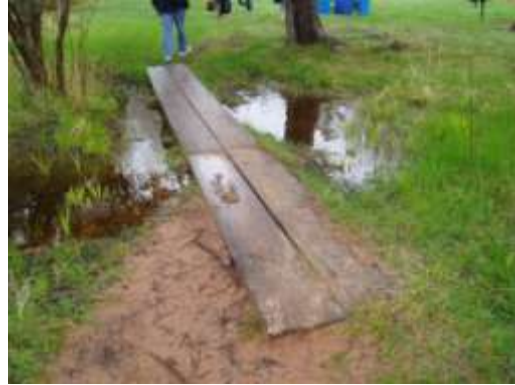
4. APIS Sand Island. Route between dock and camping area.

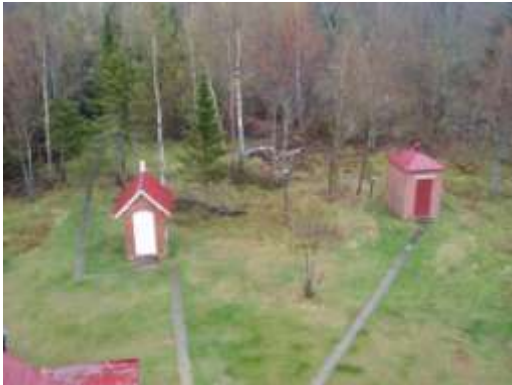
5. APIS Sand Island. Light Station. Typical route at light station.

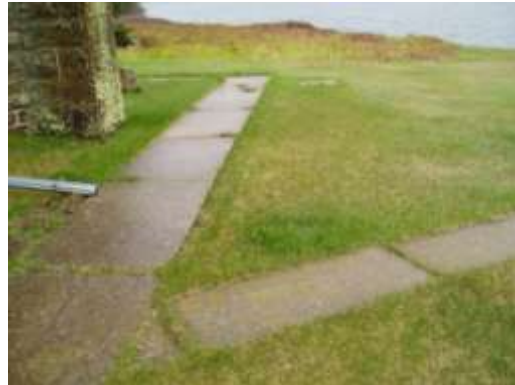
6. APIS Sand Island. Light Station. Typical route around Light Station Quarters.

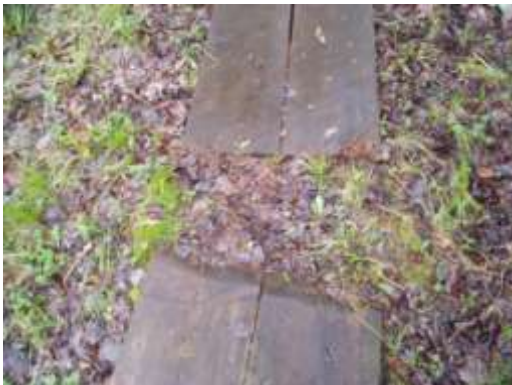
Route	There is not currently an accessible route from the site arrival point (dock at East Bay) to the light station. The 2 mile route is relatively flat and approximately 60% 'boardwalk' (with boards running parallel to the direction of travel, 24" wide). <i>ABA F206.2</i>	► Create an accessible route from the public dock to the light station.	1	Short term
Light Station Quarters: <i>The Light Station Quarters is located on the north end of Sand Island. It is currently used as housing for employees/volunteers as well as tours of the light. Currently, tours enter through the main entry of the Light Station Quarters. Interpretive plans for the building call for future visitor access to the kitchen entry.</i> National Register of Historic Places				
Entry	There is currently a 40" rise to the main entry of the Light Station Quarters. <i>ABA F206, 303</i>	<input type="checkbox"/> Construct a ramp with a 1:12 maximum slope. Include required handrails and edge protection. <input type="checkbox"/> Construct a 'ramp' with a 1:20 maximum slope. ► Create an accessible entry to the kitchen if the kitchen is used for visitor programs.	2	Long term

7. APIS Sand Island. Route from dock to Light Station.

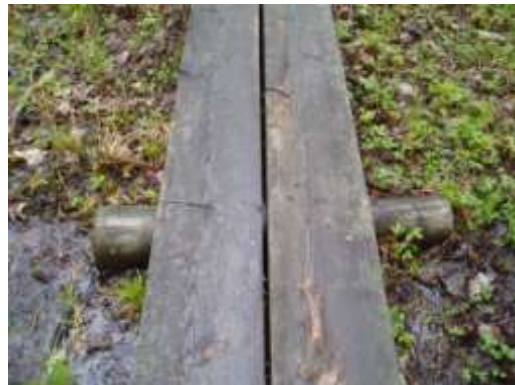
8. APIS Sand Island. Route from dock to Light Station.

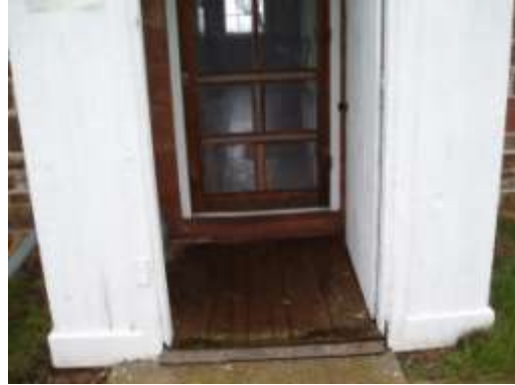
Kitchen Entry	There is currently a 7" rise to the kitchen entry of the Light Station Quarters. <i>ABA F206, 303</i>	<input type="checkbox"/> Construct a ramp with a 1:12 maximum slope. Include required handrails and edge protection. <input type="checkbox"/> Construct a 'ramp' with a 1:20 maximum slope. ➤ Create an accessible entry to the kitchen if the kitchen is used for visitor programs.	1	Long term
Kitchen Entry- Door Hardware	The operable door hardware at the kitchen entry to the Light Station Quarters is currently a knob style. <i>ABA 309.4</i>	<input type="checkbox"/> Replace the knob style hardware with a style that does not require tight grasping, pinching or twisting of the wrist to operate (such as a lever). <input type="checkbox"/> Prop doors in the open position when the Light Station Quarters is open to the public, eliminating the need to use the knob style hardware. ➤ At such time the building is used by the public, replace the door hardware.	2	Long term

10. **APIS Sand Island.** Light Station Quarters- kitchen entry.

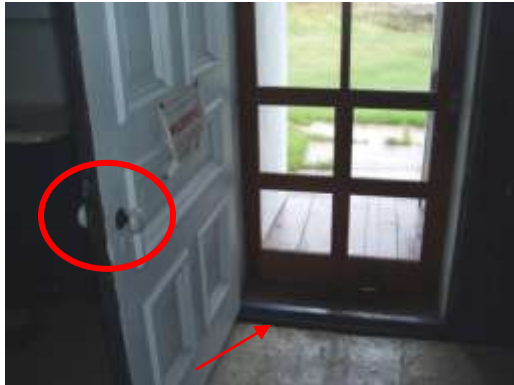
11. **APIS Sand Island.** Light Station Quarters. View of kitchen entry from interior.

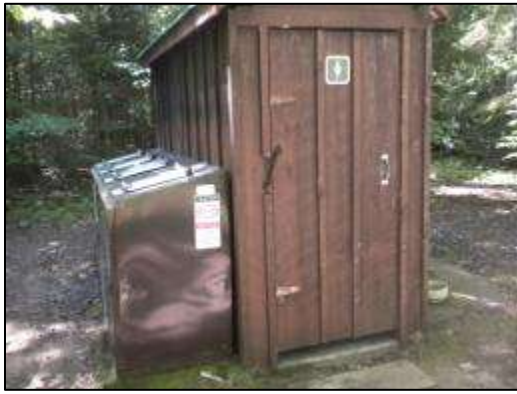
Vault Toilets	The 4 existing vault toilets (both doubles) do not currently provide any features of accessibility. <i>ABA F213.2</i>	<ul style="list-style-type: none"> ➤ Replace 1 of the existing vault toilets with an accessible style. <input type="checkbox"/> Add an additional accessible vault toilet. 	2	Long term
Trail	The trail to the Brownstone Quarry is not accessible. There are 23 steps at the trailhead and the trail surface is rocky and steep. <i>Draft Accessibility Guidelines for Outdoor Developed Areas F247</i>	<ul style="list-style-type: none"> <input type="checkbox"/> As new trails are developed, create an accessible trail. ➤ Take advantage of reconstruction and maintenance projects to consider providing features of accessibility such as passing spaces where appropriate. 	3	Long term
Staff Housing	The staff housing is not currently accessible and is not currently used. <i>ABA F233.4</i>	<ul style="list-style-type: none"> <input type="checkbox"/> Remodel the staff housing to provide features of accessibility, including creating an accessible entry. <input type="checkbox"/> At such time remodeling occurs, provide features of accessibility, including an accessible entry. ➤ Remove staff housing and convert the location to an accessible group campsite. 	1	Long term

7. APIS Stockton Island Quarry Bay. View of typical vault toilet.

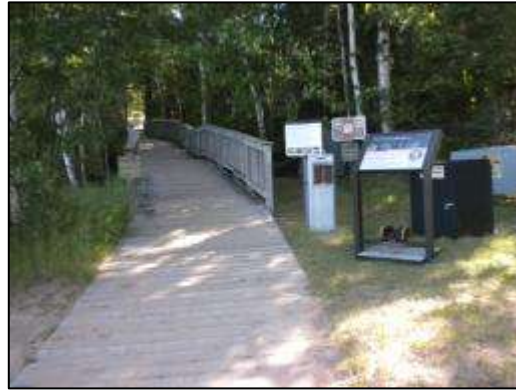
Item	Deficiency	□ Possible Solutions (recommended action indicated by: ►)	Barrier Level	Timeframe
Fee Station and Waysides	There is a fee station and wayside located in the sand near the boardwalk leading from dock 1. <i>ABA 302</i>	<input type="checkbox"/> Add an accessible route and approach to the fee station. ► Extend the boardwalk to create an accessible route to the fee station. <input type="checkbox"/> Relocate the fee station to an accessible location.	3	Short term
Dock Area	There is a gathering area on shore near dock 1 that provides 2 picnic tables, a boot scraper, bear locker and hot coal box; all are positioned in grass. <i>Draft Accessibility Guidelines for Outdoor Developed Areas F244.5</i>	► Expand the boardwalk or provide other firm, stable surface to provide a route to 1 of the picnic tables, the boot scraper and hot coal box. <input type="checkbox"/> Provide a firm, stable surface throughout the gathering area. <input type="checkbox"/> Relocate 1 of the picnic tables, the boot scraper and the hot coal box so they are located along the existing boardwalk.	2	Short term

2. APIS Stockton Island Presque Isle. View of route to visitor center. The dock area provides a fee station and boot scraper that are currently located in the grass.

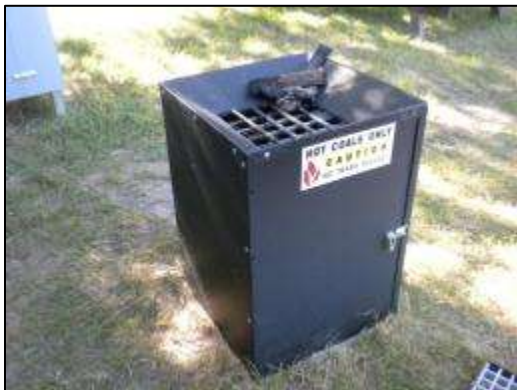
3. APIS Stockton Island Presque Isle. View of hot coal box.

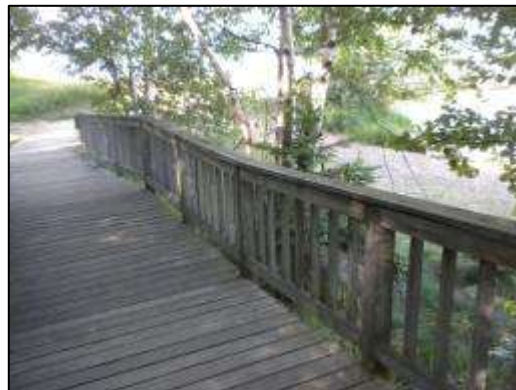
Dock Area- Ramp	A wood ramp creates an accessible route from Dock 1 to the visitor center, ranger station, vault toilets and campsite 1. The ramp does not currently have compliant handrails but does have guardrails on both sides. <i>ABA 505.2</i>	► Add handrails to both sides of the ramp (~175 in ft).	2	Short term
Dock 2	The 2nd dock is not currently located on an accessible route, there are 17 steps on the route from the dock to the ranger station and campsites. <i>Based on ABA F216.6</i>	<input type="checkbox"/> Post a sign on the dock regarding the availability of an accessible route at Dock 1. ► Add information to park brochures and websites regarding the availability of an accessible route at Dock 1.	1	Immediate
Visitor Center- Entry	There is currently knob style hardware at the entry door to the visitor center. <i>ABA 309.4</i>	► Replace the knob style hardware with a style that does not require tight grasping, pinching or twisting of the wrist to operate (such as a lever).	2	Short term

4. APIS Stockton Island Presque Isle. Route from dock 1 to the visitor center. Handrails are not currently provided on the ramp.

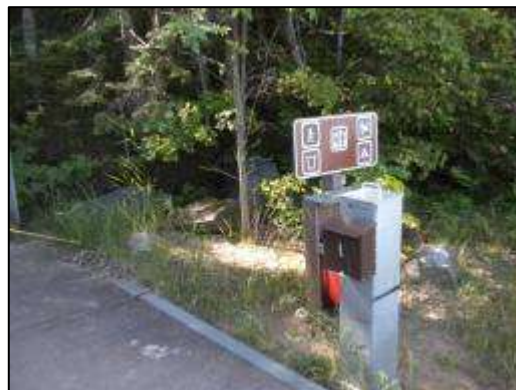
6. APIS Stockton Island Presque Isle. View of fee station at dock 2, located adjacent to the dock.

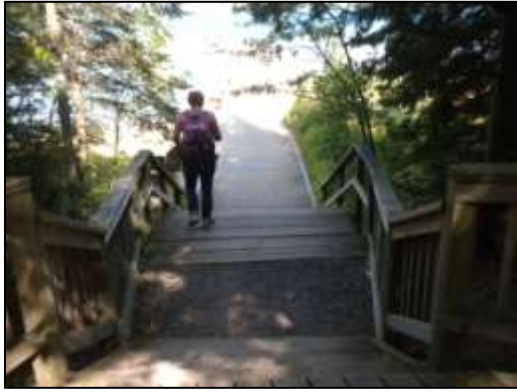
7. APIS Stockton Island Presque Isle. Route from the visitor center to dock 2.

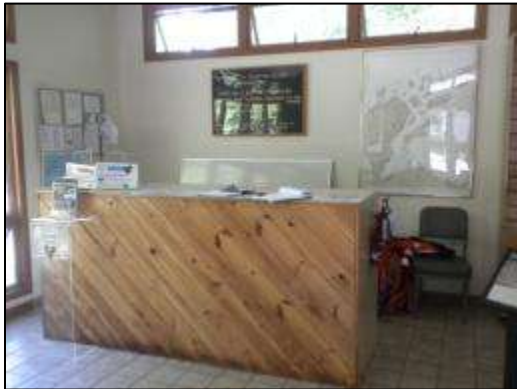
9. APIS Stockton Island Presque Isle. The counter at the visitor center is currently at 42".

Visitor Center- Counter	The counter is currently at 42". A clipboard is currently used for guests to register for a campsite. <i>ABA 904.4.1</i>	<input type="checkbox"/> Replace the counter with a style that provides a 36" wide section at 36" high maximum. ► Modify the existing counter to provide a 36" wide section at 36" high maximum.	3	Long term

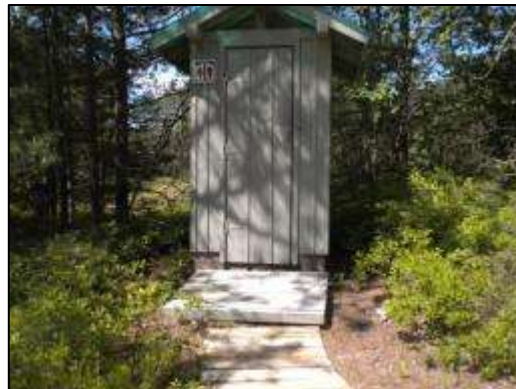
18. APIS Stockton Island Presque Isle. View of vault toilet at Julian Bay.

Vault Toilet-Julian Bay	There is a vault toilet located near Julian Bay. the vault toilet does not currently provide any features of accessibility. It is 40" wide x 52" deep and provides a 21 1/2" clear door opening. <i>ABA F213.2</i>	<ul style="list-style-type: none"> ➤ Replace the existing vault toilet with an accessible style. <input type="checkbox"/> Add an additional accessible vault toilet. 	1	Long term
Vault toilet-Julian Bay	There is not currently an accessible route to the vault toilets from the campsites. A boardwalk has been added over the sand, it is currently 32" wide and some of the boards are spaced 3" apart. <i>Draft Accessibility Guidelines for Outdoor Developed Areas 1016.3</i>	<ul style="list-style-type: none"> ➤ Replace the existing boardwalk with a style that provides 36" minimum width. 	2	Long term
Campsite #1-Picnic Table	Campsite #1 is the designated accessible campsite, it is located on an accessible route from Dock 1 and the visitor center. Many features of accessibility have been provided. Clear ground space is not currently provided on all sides of the picnic table. <i>Draft Accessibility Guidelines for Outdoor Developed Areas 1011.2.1</i>	<ul style="list-style-type: none"> ➤ Relocate the existing picnic table to provide 36" along all sides of the picnic table. 	2	Immediate

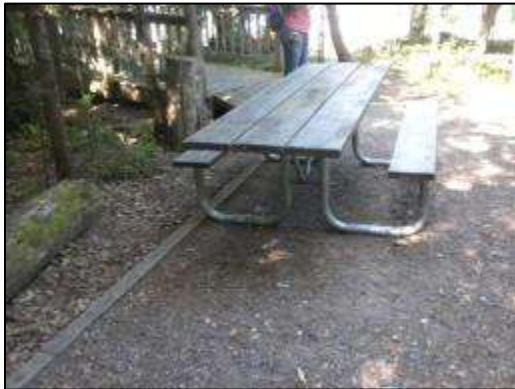
27. APIS Stockton Island Presque Isle. View of picnic table in campsite 1. Extensions provide knee and toe clearance on both ends.

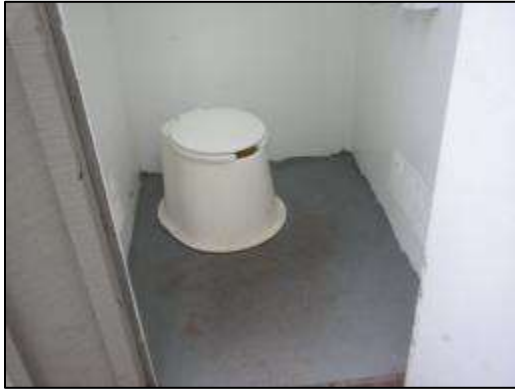
31. APIS Stockton Island Presque Isle. View of typical vault toilet interior.

Vault Toilets-2-19	There are 7 vault toilets (3 doubles, 1 single). The existing vault toilets do not currently provide any features of accessibility. <i>ABA F213.3</i>	<input type="checkbox"/> Replace 1 of the existing vault toilets with an accessible style. <input type="checkbox"/> Add an additional accessible vault toilet at a location served by an Outdoor Recreation Access Route (ORAR). ➤ No action. Provide an accessible toilet at the visitor center.	1	Long term
Beach Access	Campsites 9 and 14 have been converted to beach access routes and provide a "sand ladder". There is not currently an accessible beach access route. <i>Draft Accessibility Guidelines for Outdoor Developed Areas F248</i>	➤ Create an accessible beach access route near site 1 (a sand ladder is currently provided at this location).	1	Short term
Staff Housing	The staff housing is not currently accessible and is not used by the public. <i>ABA F233.4</i>	<input type="checkbox"/> Remodel the staff housing to provide features of accessibility, including creating an accessible entry. ➤ At such time remodeling occurs, provide features of accessibility as required by ABAAS.	1	Long term

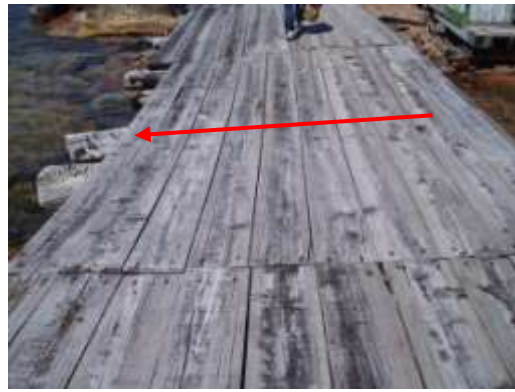
2. APIS Devils Island. Dock cross slope.

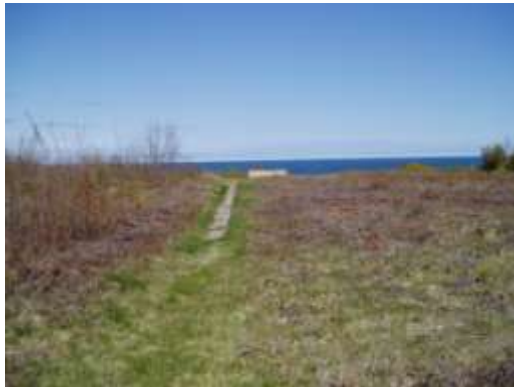
3. APIS Devils Island. Light Station. There are segments of a hard surface route throughout the light station.

Light Station-Route	There is not currently an accessible route connecting the various structures of the light station, including: Keepers Quarters, Assistant Keepers Quarters, Fog Signal Building or the Light Tower. There are segments of concrete path throughout the light station, but they do not connect all of the structures. <i>ABA 403.5.1</i>	<input type="checkbox"/> Create an accessible route (new or rehabilitated existing path). ► No action, there is no public access within these structures other than the light tower.	2	Long term
Light Station-Route	There is not currently an accessible route from the site arrival point (dock at the south end of Devils Island (boathouse site) or the east landing near the light station) to the light station. There are steep segments on the ~1 mile route from the dock, the east landing is directly onto the rocks. <i>ABA F206.2</i>	► No action at this time. The route from the dock to the light station is within the Gaylord Nelson Wilderness. Provide a light station experience at an accessible location.	2	Long term

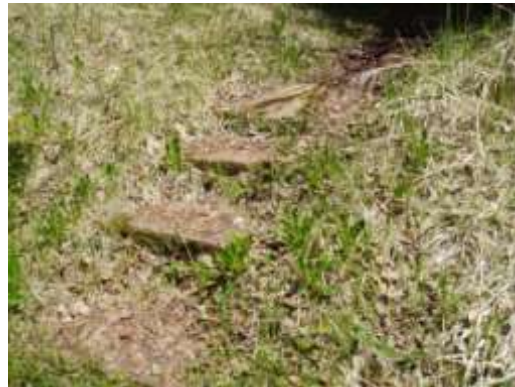
4. APIS Devils Island. Light Station. Route from the dock includes steep sections near the dock.

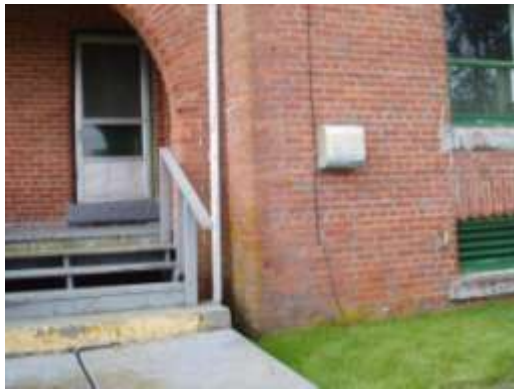
7. APIS Devils Island. Keepers Quarters. Main entry not currently accessible.

Keepers Quarters-Entry	There is currently a 10" rise at the threshold of the entry door. ABA 404.2.5	➤ Address the 10" rise at the threshold at such time an accessible route is added.	1	Long term
Vault Toilet- Light Station:				
Vault Toilet-Light Station	The vault toilet does not currently provide any features of accessibility and is currently located up 8 steps due to the shallow depth to bedrock. ABA F213.2	<input type="checkbox"/> Replace the existing vault toilet with an accessible style. <input type="checkbox"/> Add an additional, accessible vault toilet. ➤ Continue to evaluate alternate toilet styles and options that will work with the shallow bedrock/terrain.	1	Long term
Vault Toilet-Light Station	There is not currently an accessible route to the vault toilet. ABA F206.2	➤ Create an accessible route to the accessible vault toilet (when provided).	2	Short term
Camping:				
Camping	There is one campsite provided near the dock. Currently no features of accessibility are provided at this campsite. <i>Draft Accessibility Guidelines for Outdoor Developed Areas F244.1</i>	<input type="checkbox"/> Modify the existing campsite to provide features of accessibility. ➤ No action at this time. Accessible camping is provided at other locations within the park.	1	Long term

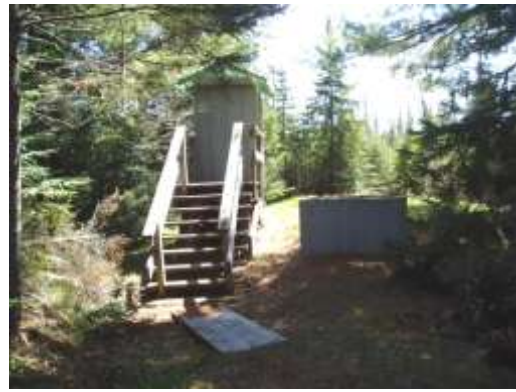
8. APIS Devils Island. Vault Toilet.

Vault Toilet-Camping	There is 1 vault toilet serving the camping area. Currently the vault toilet does not provide any features of accessibility. ABA F213.2	<input type="checkbox"/> Replace the existing vault toilet with accessible styles. <input type="checkbox"/> Add an additional, accessible vault toilet. ➤ At such time the existing vault toilet is replaced for other reasons, replace with an accessible style.	1	Long term
